HBMP Annual Data Report

**Peace River Hydrobiological
Monitoring Program
*2015 HBMP Annual Data Report***

**Southwest Florida Water Management District
Water Use Permit 20010420.008**

**Peace River Manasota Regional
Water Supply Authority**

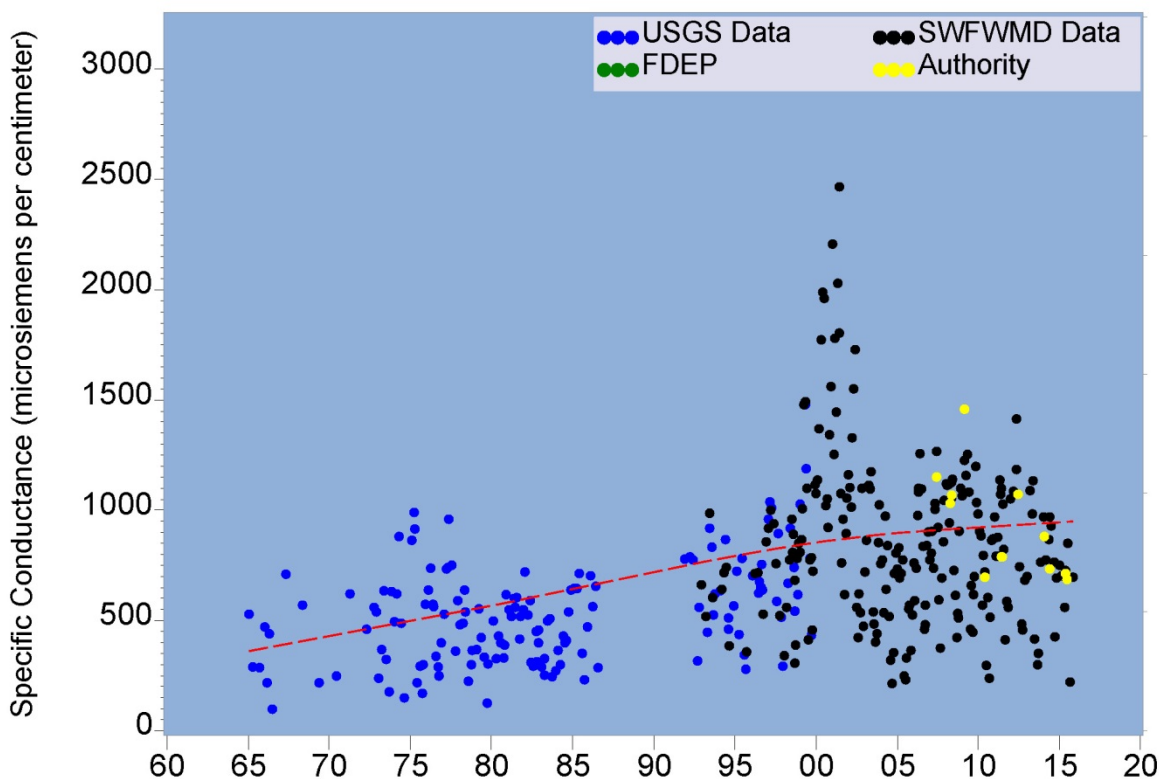
Figure 8.38 Specific conductance USGS site 2297100 / District site 24431
Joshua Creek at Nocatee - Joshua Creek basin

conductivity and related water quality parameters stem from agricultural irrigation practices throughout the basin and have recently been particularly prevalent during drought conditions.
